Research Journal of Pharmaceutical, Biological and Chemical Sciences

Paddy Thresher Injuries Causing Lower Limb Amputations in Cauvery Delta Region

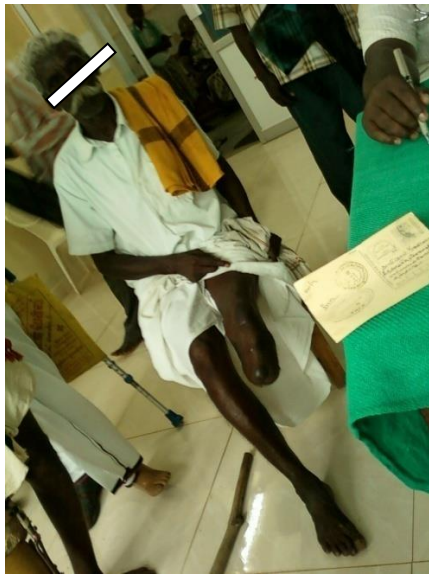
Figure 1

Figure 1: A Paddy Thresher Injury victim below knee amputee his mail seen on the table.

their legs into a thresher drum which was run by power from a diesel engine. None of them had any formal training. Most common site of their amputation was below knee amputation. One of the victims who came in person is shown in figure 1 and after fitting his artificial limb is seen in figure 2.

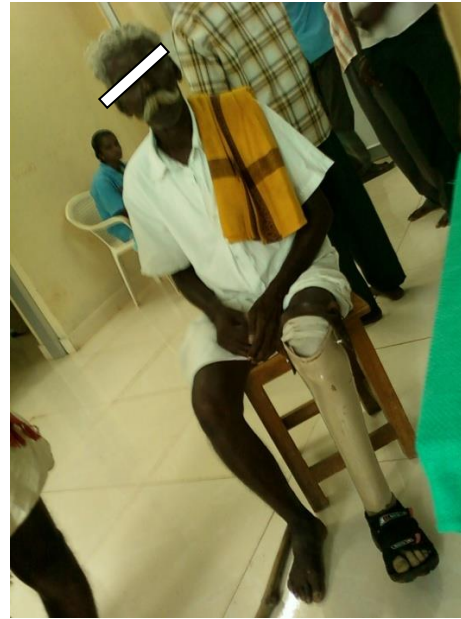
Figure 2

Figure 2: The Paddy Thresher Injury victim seen in Figure 1 is shown with his artificial limb fitted in our artificial limb sub centre.

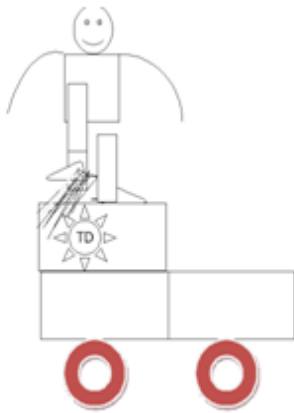
Figure 3

Figure 3: Present practice of pushing the crop with lower limbs. TD is the thresher drum
 Figure 4: Recommended safe practice of feeding the stalk with upper limbs standing on a separate stable platform. TD is the thresher drum

Details of all 18 PTI patients are presented in table 1. One PTI victim who was given artificial limb is also seen in figures 1 and 2. All of them are males mostly in the fourth and fifth decade. None of them have crossed tenth standard. Ten were totally uneducated. Two passed fifth, one passed seventh, one passed eighth, two passed ninth standards. One each passed 4th and third standards. Only three of 18 had their injuries in the forenoon. 15 had their injuries in afternoon. They being tired sat on the top loading machine and pushed the paddy stalks with
