Fracture Body of Implant - Case Report.

This case report describes the management of a loose cement-retained implant supported sectional bridge prosthesis where the thread of the abutment screw had fractured away from the body of the screw.

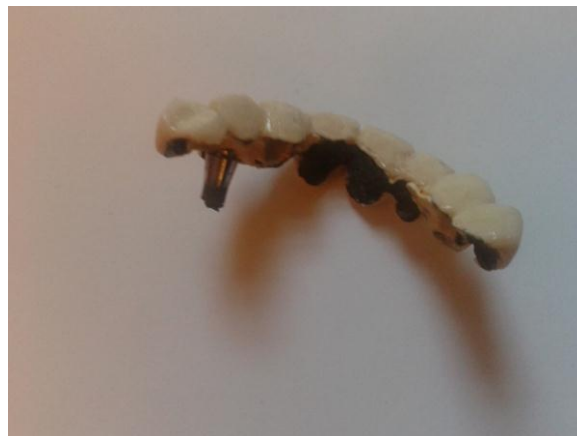
A 46years old patient complains of dislodged bridge in relation to implants on his upper teeth. History revealed that 3 years back he underwent implant supported sectional bridge treatment. On intraoral examination revealed an implant at 13 retaining the fractured segment of abutment screw within and below the head of the implant (fig 1). The other half of the fractured screw along with the abutment and fractured implant was in the dislodged crown. Fracture was in the body of the implant which resulted in failure of implant. The loose bridge was removed under local anesthesia together with implant fragment. The removal of the remaining implant fragment using bone trephine was done, followed by adequate quantity of bone graft for second fixture. An immediate temporary removable partial denture was given for replacement. Later after 6 months patient was reviewed, full thickness flap raised for placement of implant. Implant of length 13mm and diameter 3.75 mm was placed over the site and healing was complete. After 2 months abutment was placed, impression was made followed by ceramic- metal bridge prosthesis .

Figure 1: Fractured Prosthesis with Body of Implant

Implant body fracture is a rare complication of implant treatment occurring only in 0.6% of implant cases [5]. Damage of the internal implant thread can lead to failure of implant due to failure to restore. Occlusal overload is also a cause. Bridge with cantilever design will further increase bending forces on implants and the supporting bone leading to bone loss.

Rangert *et al.* [7] found that partial bridges with cantilever designs accounted for 83% of implant fractures and that 90% of fractures occurred in the posterior regions. It has been shown in animal studies that crater-like bone loss will occur around implants with excessive dynamic loading [8] and this loss of bone support will allow flexing of an implant under loading and possibly contribute to a fatigue stress
