Research Journal of Pharmaceutical, Biological and Chemical Sciences

Work Capacity and Durability of Rolling Cutter Drill Bits (Analysis of Criteria and Research Results).

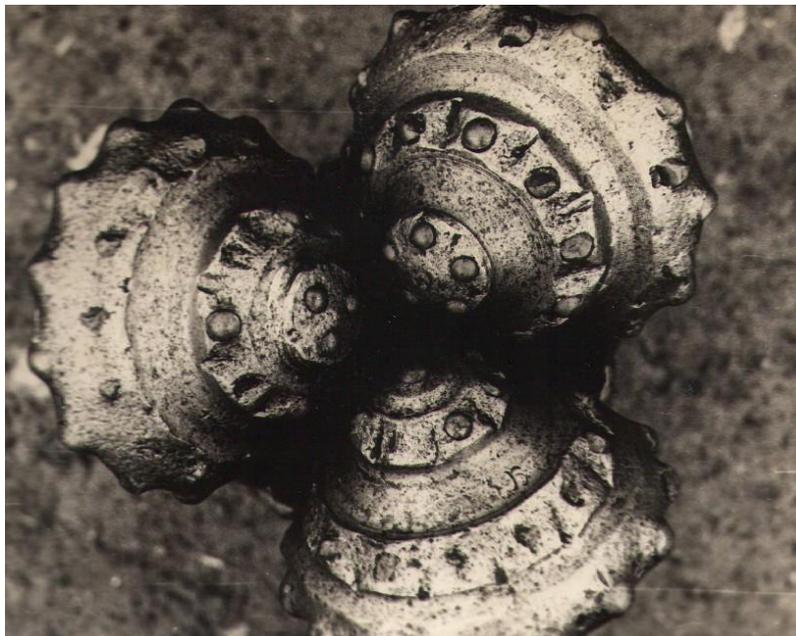
Figure 3. Typical destruction cases of cutting structure for the worked off bits of the type Ш215, 9К-ПВ

The number of destroyed teeth is different in various crowns. For bits III215, 9К-ПВ the largest share of destroyed teeth falls on middle crowns. Thus, 42.3% and 39.5% of teeth are destroyed on the first bit rolling cutter on B and C crowns respectively, while there are only 16.0% and 23.3% on A and D crowns. Figure 3 shows typical cases of the cutting structure destruction for the worked off bits of this type.

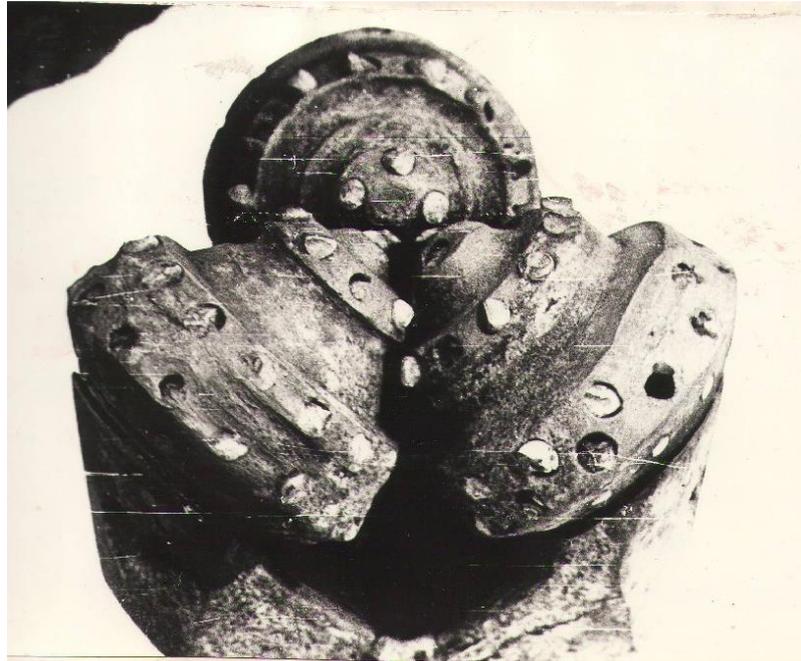
**Figure 4. Typical destruction cases of cutting structure for worked off bits
Ш215, 9TK3-ЦБ-3**

For bits of type TK3 the largest share of teeth destruction falls on the peripheral and middle crowns, and the number of destroyed teeth on the top crowns is small. Breakdowns are predominant destruction type

for the bits of type TK3. Figure 4 shows the typical destruction cases of cutting structure for the worked off bits of this type.
