A Bizarre Agricultural Injury and Its Analysis.

S Kumaravel*, and Anand Jain.

Department of Orthopaedic Surgery, Government Thanjavur Medical College, Medical College Road, Thanjavur 613004, Tamil Nadu, India.

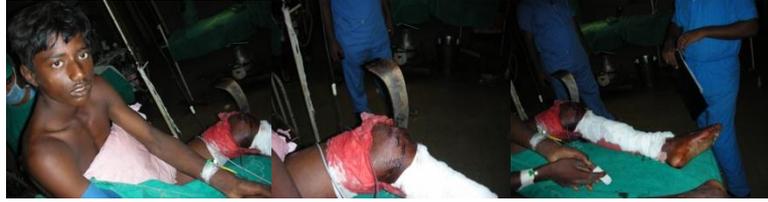
figures 1-3: showing the patient as received after the injury.

A 16 year old boy presented to the casualty with severe bleeding wound of left thigh and with a flat iron blade like object projecting from the wound. The object was almost 15 cm out of the wound. figures 1-6. His distal vascularity was intact.

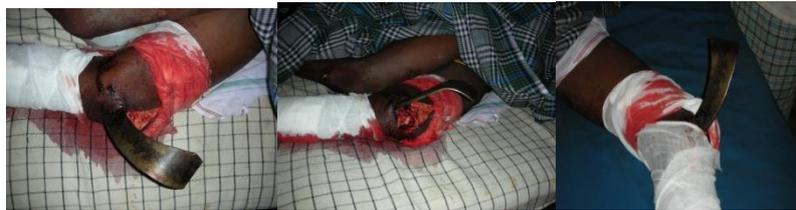
Figures 4-6: showing the presentation of the patient with the flat object in the thigh

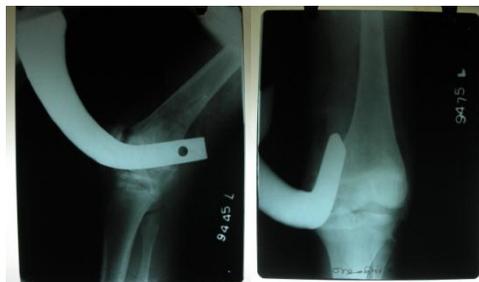
His X-rays are seen in figures 7, showing the iron object almost 3 inches inside the medial part of the left knee .

Figure 7: showing the radiographs of the patient with the flat object medial aspect of femur.

Patient was taken up for emergency surgery. Under spinal anesthesia the wound was debrided and explored. The part of the blade on the medial side of the patient's knee is identified and removed. After lavage with ten litres of saline and closed with a drain.

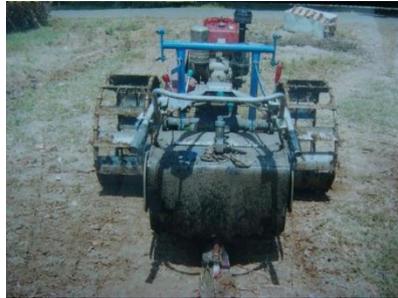
Figure 9: The machine –a walk behind type tractor seen from one side

The place of the incidence was visited and the machine was inspected and photographed. The front and back views of the machine, a walk behind type tractor is presented in figures 9, 10, 11. It had an engine powered by diesel. This is connected by a belt to two wheels on either side with rotating blades mounted on a steel frame. The steel connection plate is seen with the position of the nut in figure 12.

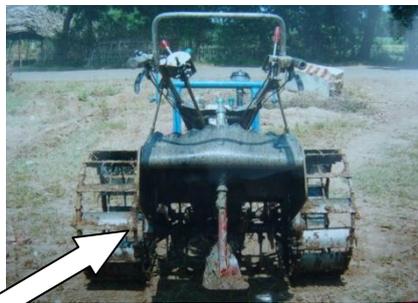
Figure 10: The arrow pointing to the tilling wheel with heavy duty blades steel linked to the connecting the central rotor and the tilling blades.

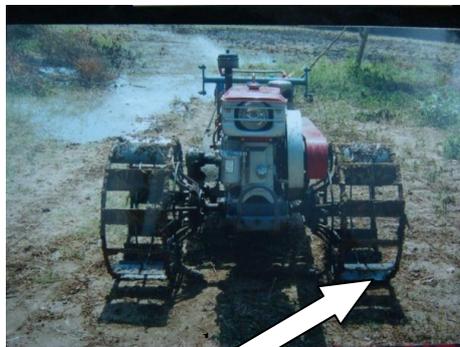
Figure 11: The arrow pointing to the steel link connecting the central rotor and the tilling wheel with heavy duty blades

The individual in this case report was tilling a wet field. The machine has two separate iron wheels which are fitted with spades. On moving the machine in the field thorough tilling of the fields happen .The wheel is connected to a central rotor by means of many oblique links marked with arrows in the picture. This link with the rotor is fixed with a bolt and nut. One of these links got dislodged from the wheel and its nut got loosened. This by backward movement of the wheel got dislodged and pierced the medial part of the right knee. The patient was fortunate in not injuring his popliteal artery in the process.

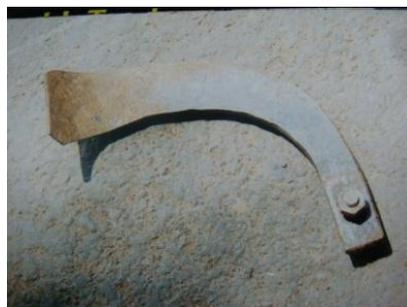
Figure 12: The steel connecting plate that was pointed in the earlier photograph is seen here. the nut has loosened and the nut side end has pierced and entered the medial aspect of the patient's thigh.
